# FACILITY COMPLIANCE INSPECTION REPORT

## Division of Waste Management Solid Waste Section

City of Durham Closed MSW Landfill  
 2115 East Club Boulevard  
 Durham, NC 27704

Post Closure Audit

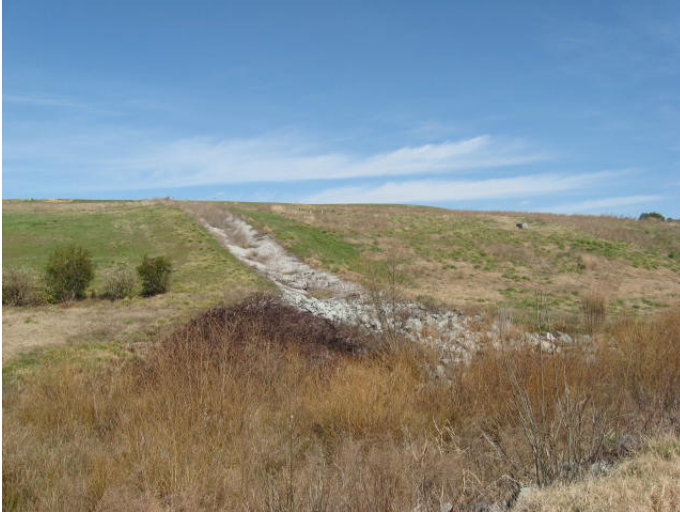
(portion of) Southern side slope

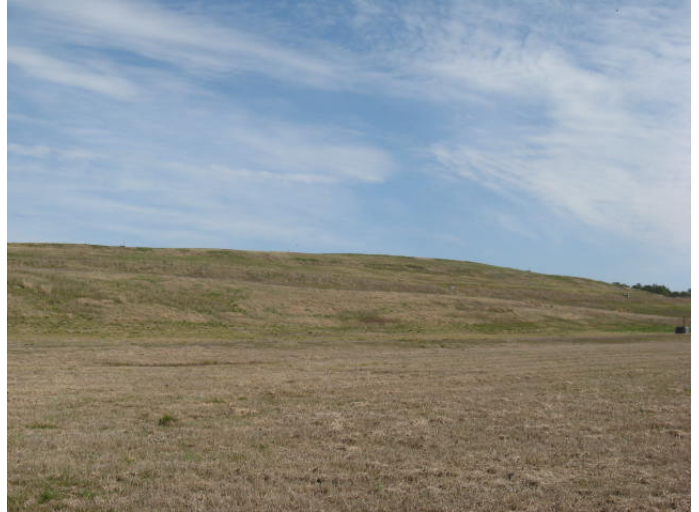
(portion of) Western side slope

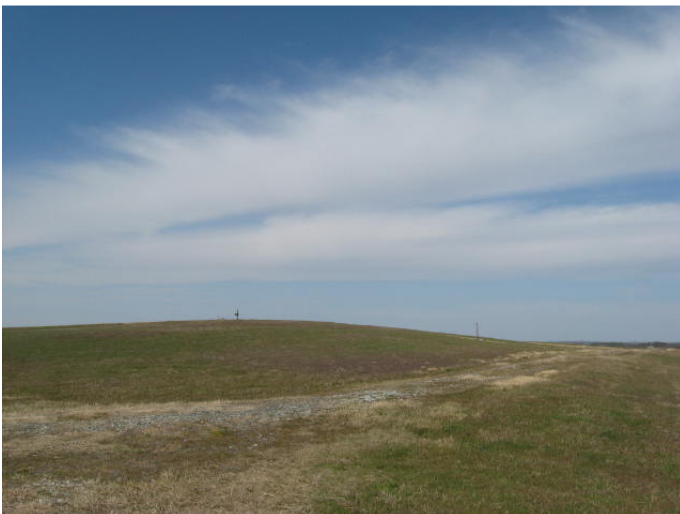
6. The landfill cap is covered with native grasses and mowed twice a year, spring and fall.
7. The landfill cap contains a small amount of woody vegetation. Mr. Lobdell stated that the woody vegetation will be removed by fall 2012.

(portion of) Northern view – landfill cap

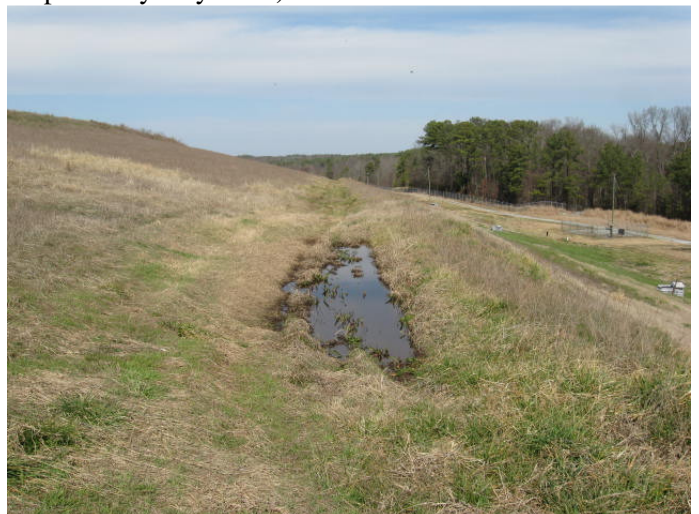
Eastern side slope – area of ponding water (to be repaired by July 2012)

13. Mr. Reedy stated that the facility has been approved by the SWS to install seven new methane monitoring wells.
14. An area of ponding water was observed along a section of berm on the east side of the landfill. Mr. Lobdell stated that a drain pipe will be installed by July 2012 to route stormwater from the cap (in the area that water is currently held) to a drainage swale.
